Manhole Inspection Summary

Manhole # S31SS1008MH

Location Address: **4701 N CHARLES ST**

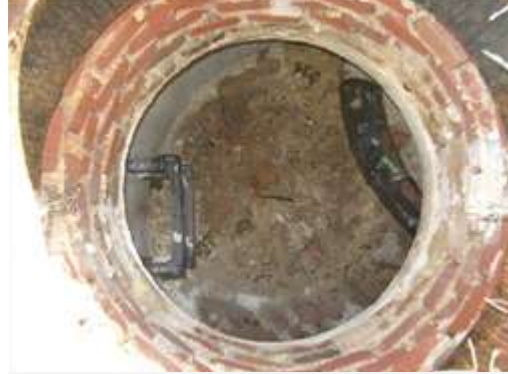
Top View

Bench ☒ Exists Material: **Brick** ☐ Parged ☒ **Debris** (not Condition related)

Channel Material: **Brick** ☐ Parged ☒ **Debris** (not Condition related)

Surcharge ☒ **Evidence Of Surcharge** Depth: **1** (ft.) ☐ Active Surcharge Present

Evidence of surcharge - Bench debris.
Channel debris.

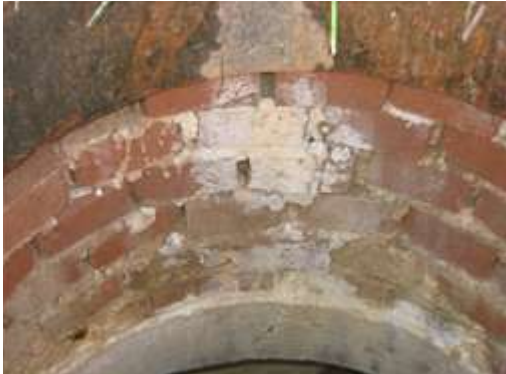
Defect

Condition: ☐ Sound ☐ Cracked ☐ Root Intrusion ☐ Loose Brick ☒ **Deteriorated**

Infiltration: ☐ None ☒ **Joint** ☐ Cracks ☒ **Mortar** ☐ Roots ☐ Wall

Infiltration: ☐ None ☒ **Joint** ☐ Cracks ☐ Mortar ☐ Roots ☐ Wall

Adjustment deterioration and infiltration.
Corbel infiltration.

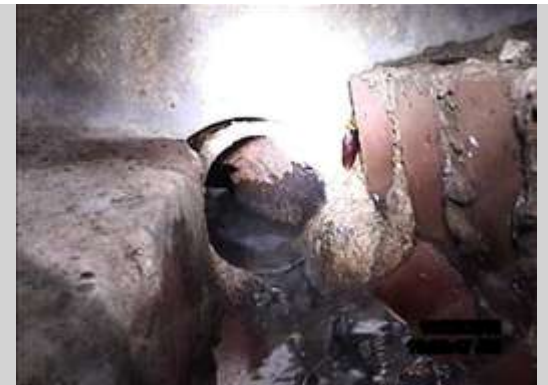
4 in. Circular Gravity Sewer Pipe In @ 4 O'Clock

Condition: ☐ Sound ☐ Cracked ☒ **Root Intrusion** ☐ Deteriorated ☐ Leaks ☐ Debris

Channel root intrusion.

Infiltration: **Evidence** Pipe Seal Cond: **Unknown**
